(NASA-CR-140444) ENVIRONMENTAL TEST
REPORT FOR THE WX-32335 SEC CAMERA TUBE
(Westinghouse Electric Corp.) 27 p HC
\$4.50 CSDL

OCTOBER 1973

WESTINGHOUSE ELECTRIC CORPORATION
ELECTRONIC TUBE DIVISION
ELMIRA, NEW YORK
14902

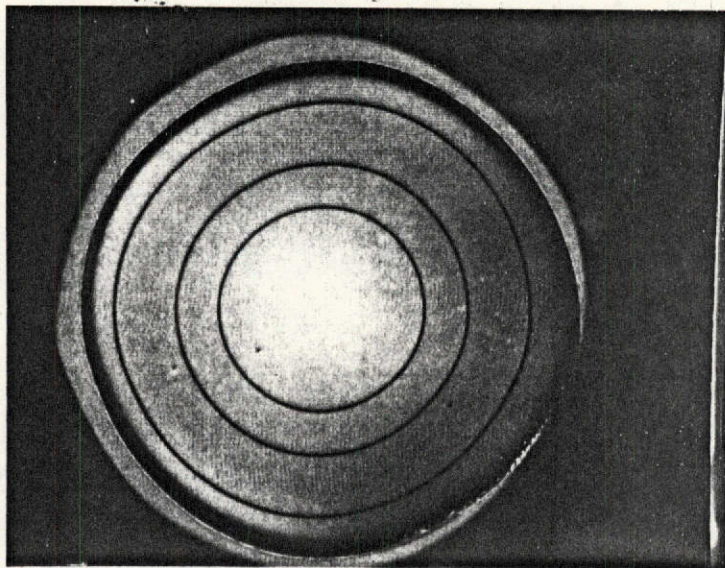
BEFORE
ENVIRONMENTAL TESTING

TUBE S/N 73-09-426

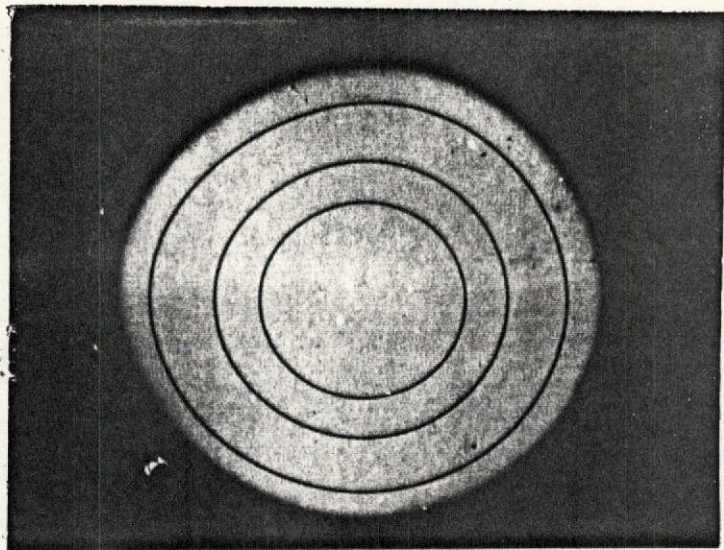
BEFORE
ENVIRONMENTAL TESTING

TUBE S/N 73 09 429

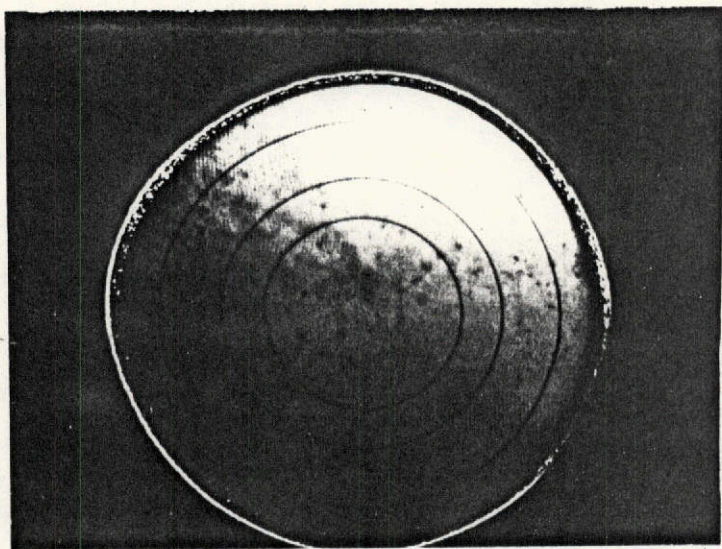
BEFORE
ENVIRONMENTAL TESTING

TUBE S/N 73 09 430

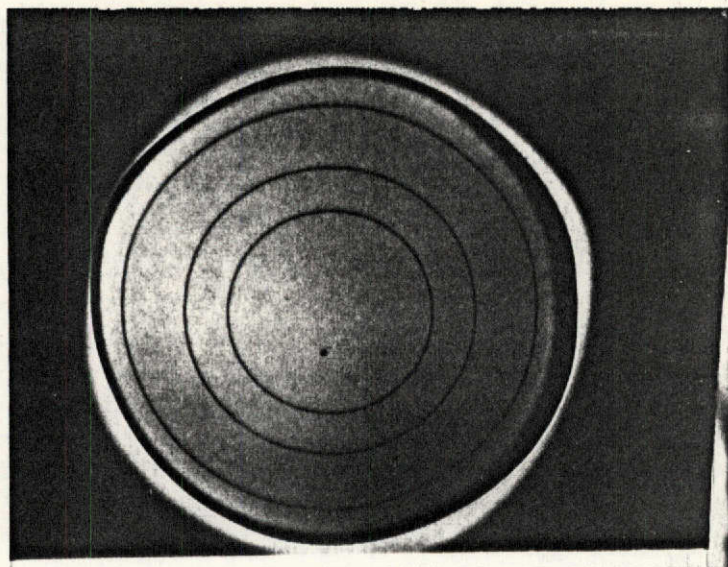
BEFORE
ENVIRONMENTAL TESTING

TUBE S/N 2317353

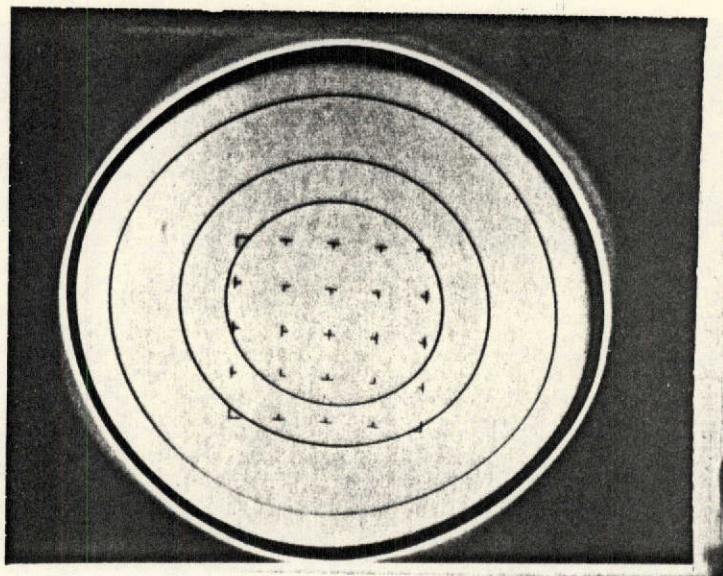
BEFORE
ENVIRONMENTAL TESTING

TUBE S/N 73 17363
